SUBJECT: Animal Feeding Operation (AFO) Compliance Inspection for Kooiker Brothers - Home, Sioux County, Facility #59078

IOWA EPARTMENT OF NATURAL RES RCES AFO INSPECTION REPORT

IOWA DEPARTMENT OF NATURAL RESOURCES AFO INSPECTION REPORT

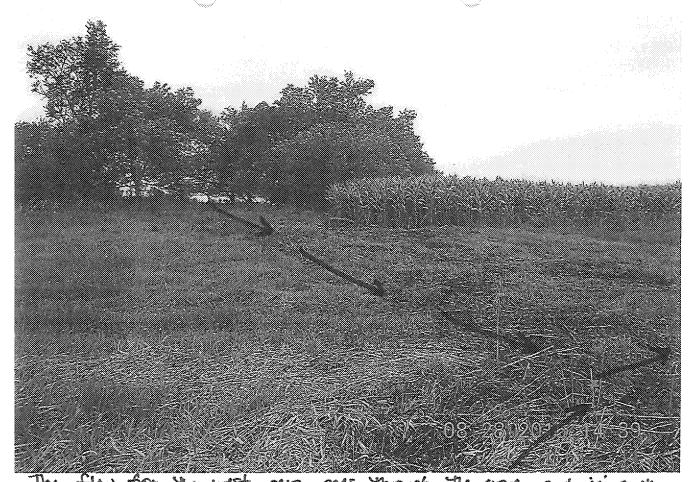
The flow from the west pen goes through the grove and joins the flow from the east pen in a grassay small along the earther containment berm.

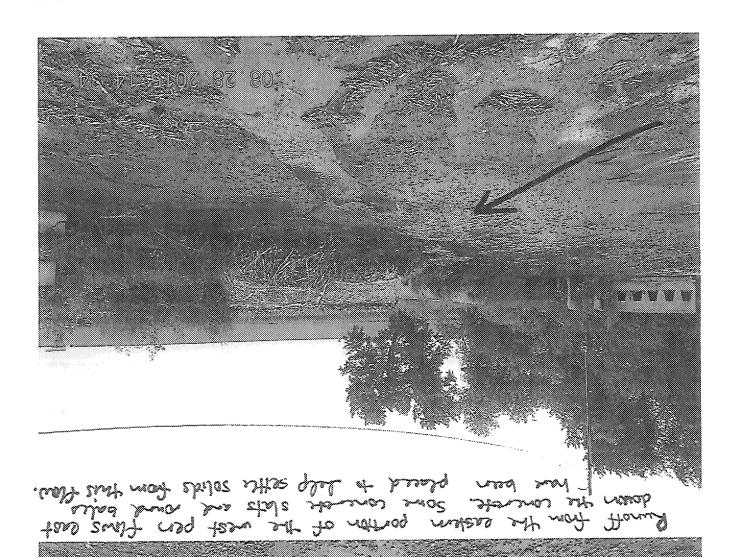
The containment bern letterds about 1/2 mile to the next, allowing all minest to see into the creek.

There are two open lot pens at this facility, each of which has concrete along the feed bunks. All runoff from the east pen flows east/northeast. An earthen berm was constructed along the east side of this facility and extends about ½ mile to the north along the creek. This berm serves as a settling and containment area and prevents open lot runoff from being discharged into the creek.

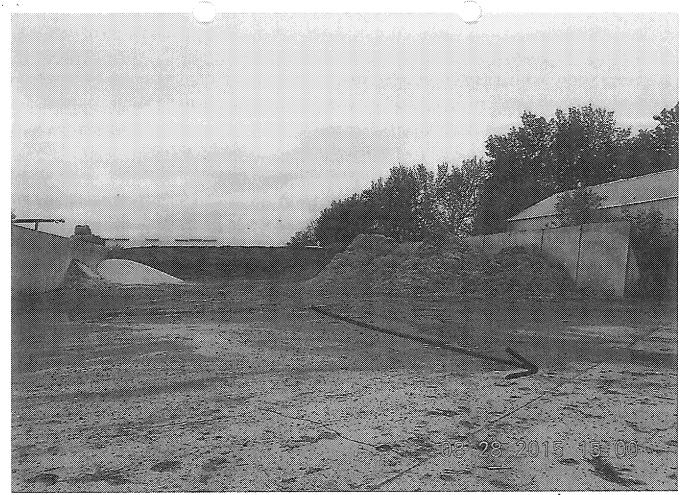
Feed for the open lot cattle is stored in a concrete bunkler and a small covered commodity sted. Routh from the feed storage area flows east around the west pen and them north into the grassy area doing the containment berm.

All runoff from stockpiles, dead animal storage, and uncovered feed storage areas is considered process wastewater, and as such, must also be controlled. All feed for the hogs is stored in covered bulk bins and there was no spilled feed observed around the bins at the time of this inspection. Feed for the cattle is stored in a concrete bunker and a covered commodity shed located in the center of the facility. Except for the open end, the silage pile is covered by plastic to reduce runoff. Any runoff from the feed storage area would flow around the east side of the west pen and then north into the grassy area along the containment berm.

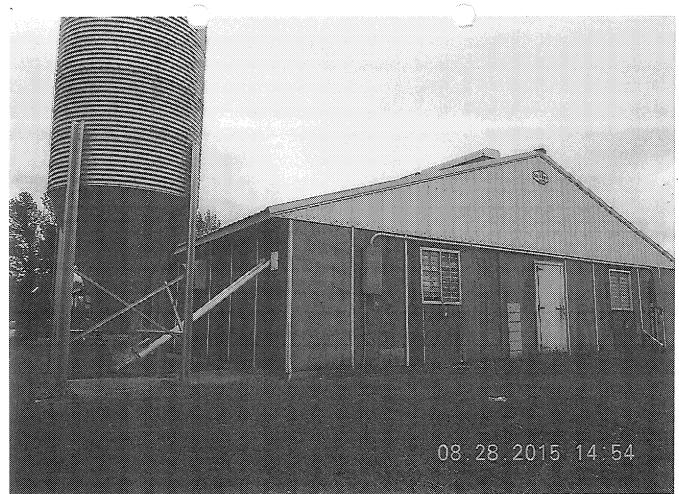
The Small north frisher barn has a Shallow (2') pit with pull plugo that drain regrune sito an outdoor circular coverex tental

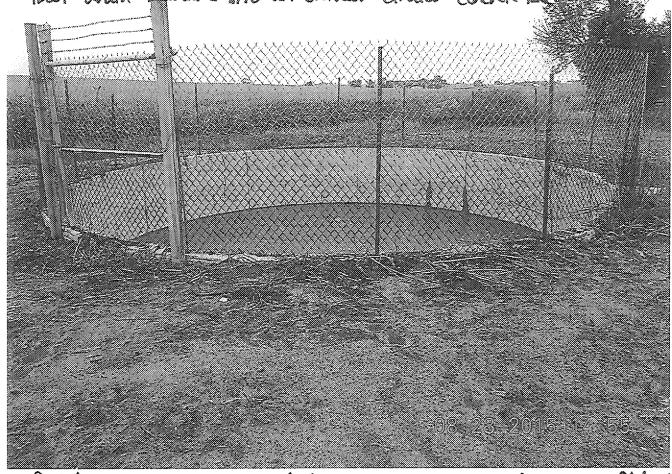
Outdoor circular consider took measures about 30' dismeter and 8' depth.
